Te Onewa Pa upgrade: a methodological case study in minimising effects on archaeological sites

**report to
Heritage New Zealand Pouhere Taonga
and
The New Zealand Transport Agency**

Date: 20 November 2018

Reference: 15-0623

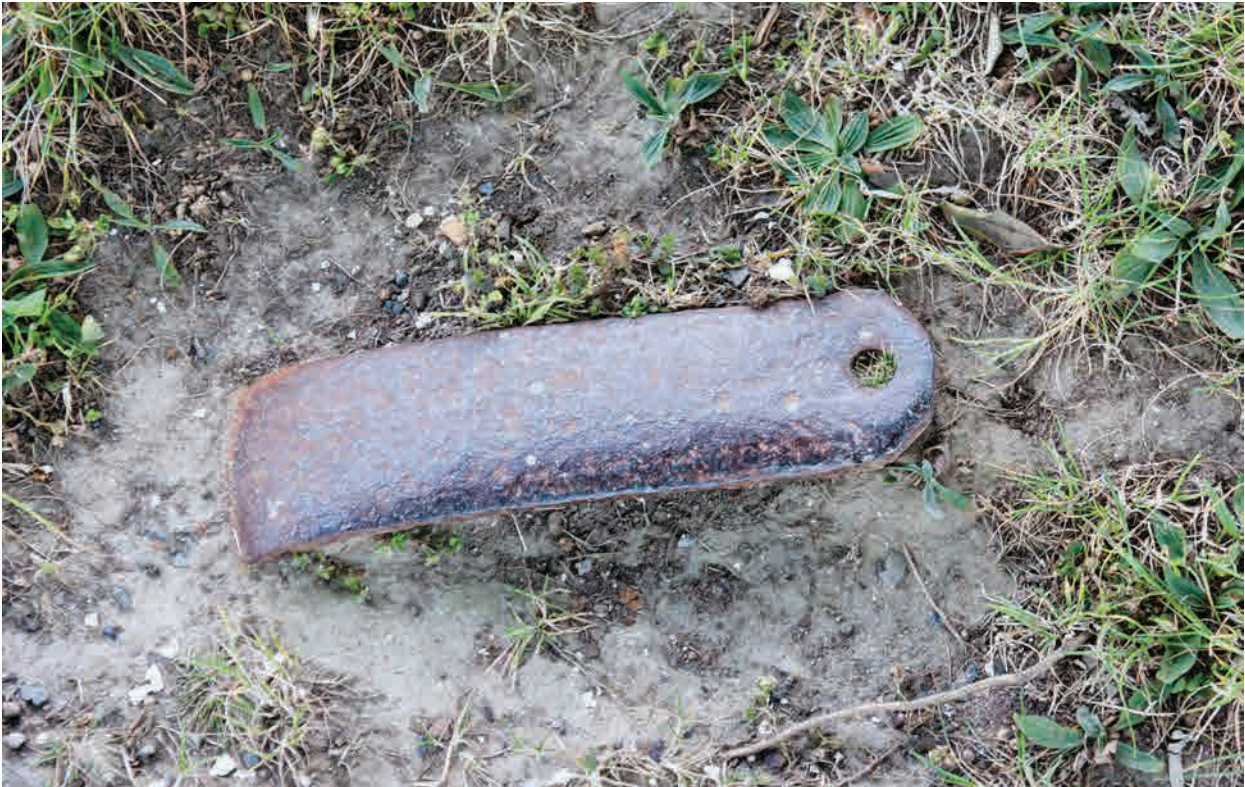
Figure 6. Stay from the 1908 flagpole still in situ.

Based on the photographic evidence and the existence of the flagpole stays still on the ground surface (Figure 6), it appears that the ground surface was not cut down as much as concluded by Harlow (2010), and although there was clearly evidence for ground disturbance it is possible that much of the pa inside the ditch was only subject to minimal disturbance.

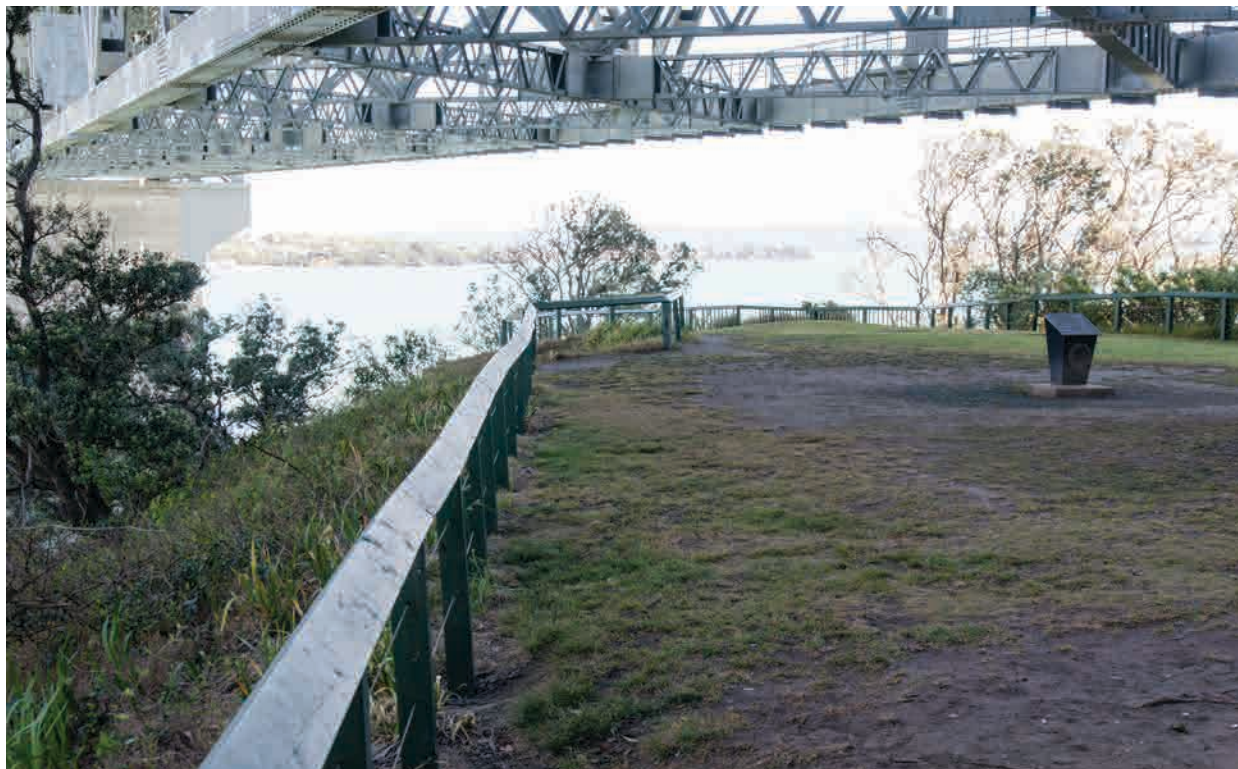
The existing perimeter fence consisted of 73 timber posts with a top rail and wire balustrade. There were no balusters and it was inadequate for containing visitors and not code-compliant. A new fence was required to, firstly keep visitors safe and away from the steep bank, and secondly prevent interference with the vegetation outside the fence that could lead to further erosion of the pa. It was determined that the existing timber post and wire fence around the

Figure 11. Previous perimeter fence.

cliff edge was to be replaced with a new steel fence, compliant with current Building Code requirements.

Extracting each post and footing as a single unit would cause a significant ground disturbance to the pa, affecting not only any potential archaeological features below the surface but also the bank stability. To ensure the works were in keeping with the concept of minimal disturbance, a methodology was devised to reutilise the current concrete footings by using a concrete coring auger to remove the existing posts and creating a hole for the new steel post and concrete to be poured into.

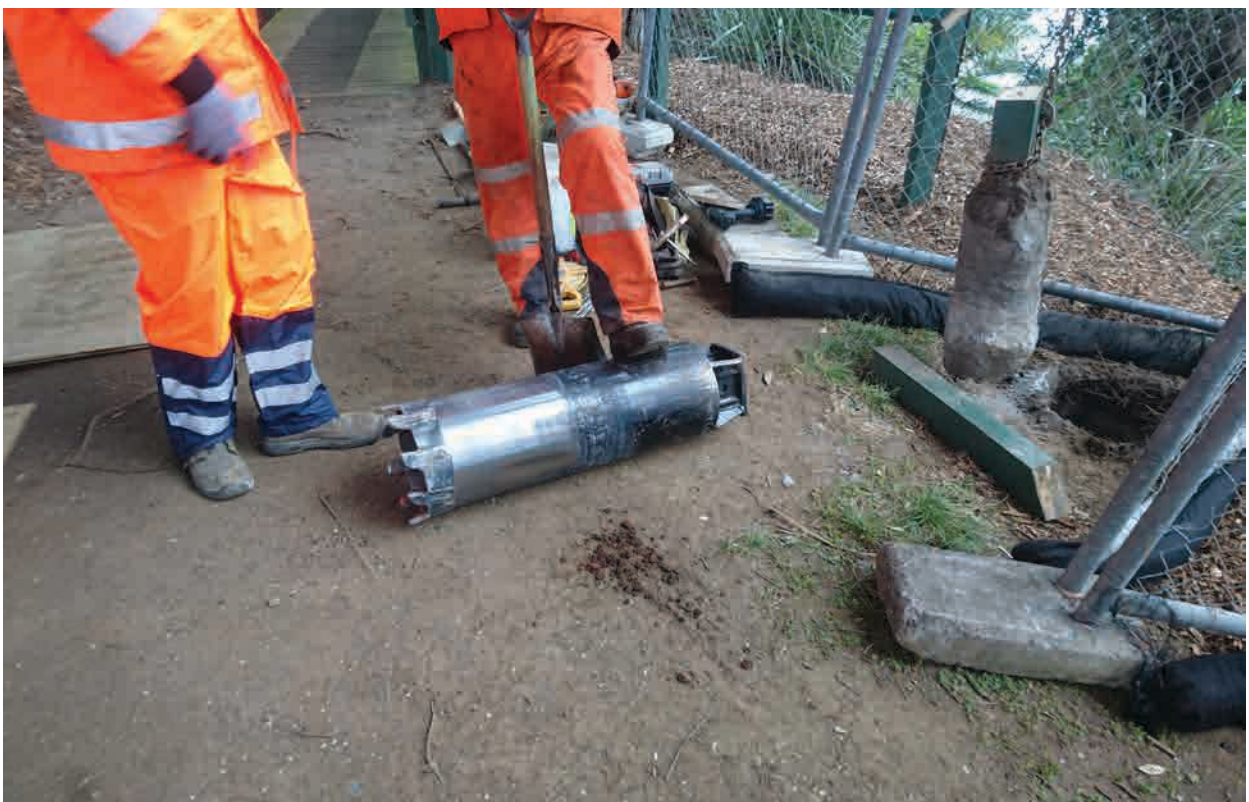
Figure 13. Extracted post and concrete with coring auger.

Starting from the eastern side and working clockwise about the reserve, the existing fence posts were cut down leaving approximately 250 mm exposed above the ground. The topsoil was then removed around the post to expose the concrete footing. A bolt was placed at the centre of the post and a guide jig was used to align the 310 mm coring auger. The post was then cored and lifted out. The hole was inspected and extended using a 280 mm auger to a final depth of 1300 mm to accommodate the new post.

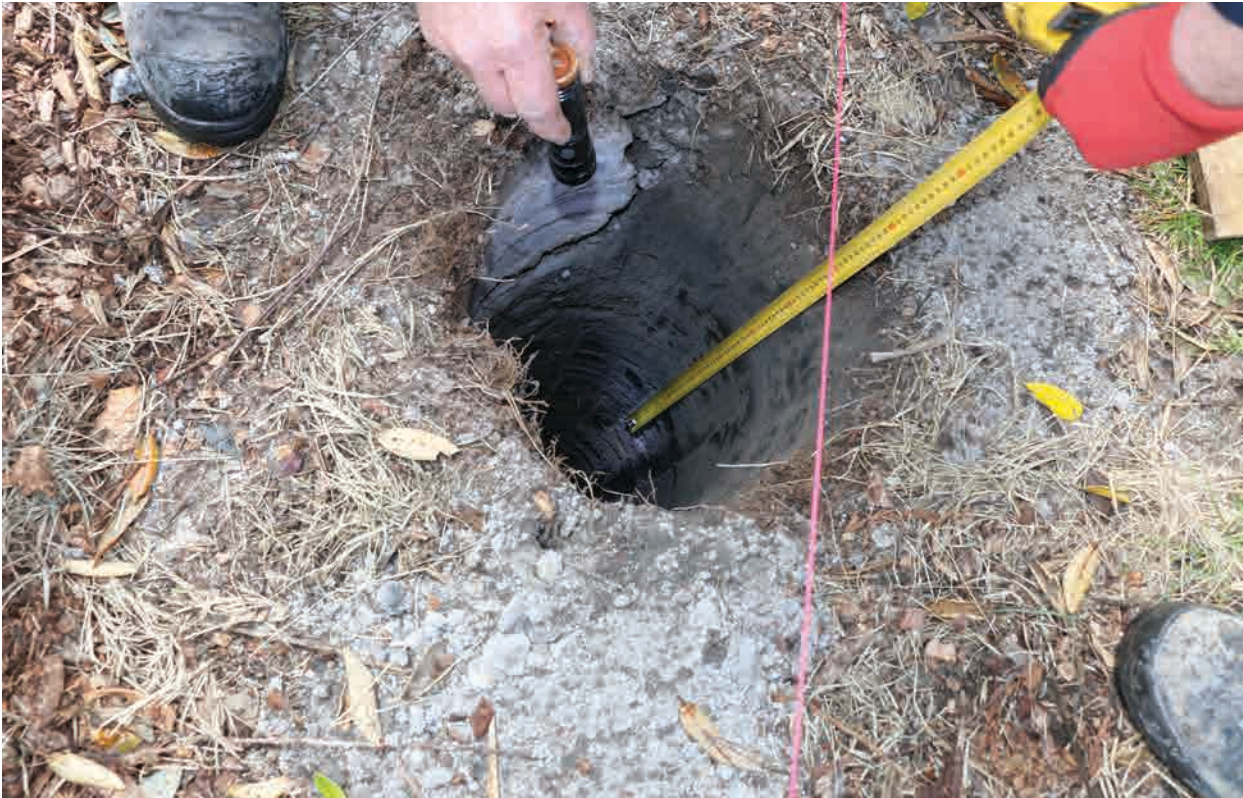
The first 18 holes that were drilled exposed a sandy topsoil that was generally 800 mm deep, overlying a sterile clay. In holes 12, 13, and 14, a concrete slab was encountered at 850 mm. The extent of the slab is unknown, but it is at least 2 m in length, and 500 mm thick. It is probably related to bridge construction. Between holes 53 and 57, redeposited midden and construction steel elements probably had a similar origin. This appears to be evidence of the modification to the pa from the construction of the Harbour Bridge, as they appear to line up with two of the

Figure 14. Hole 53 showing 800 mm of mixed topsoil with redeposited shell midden.

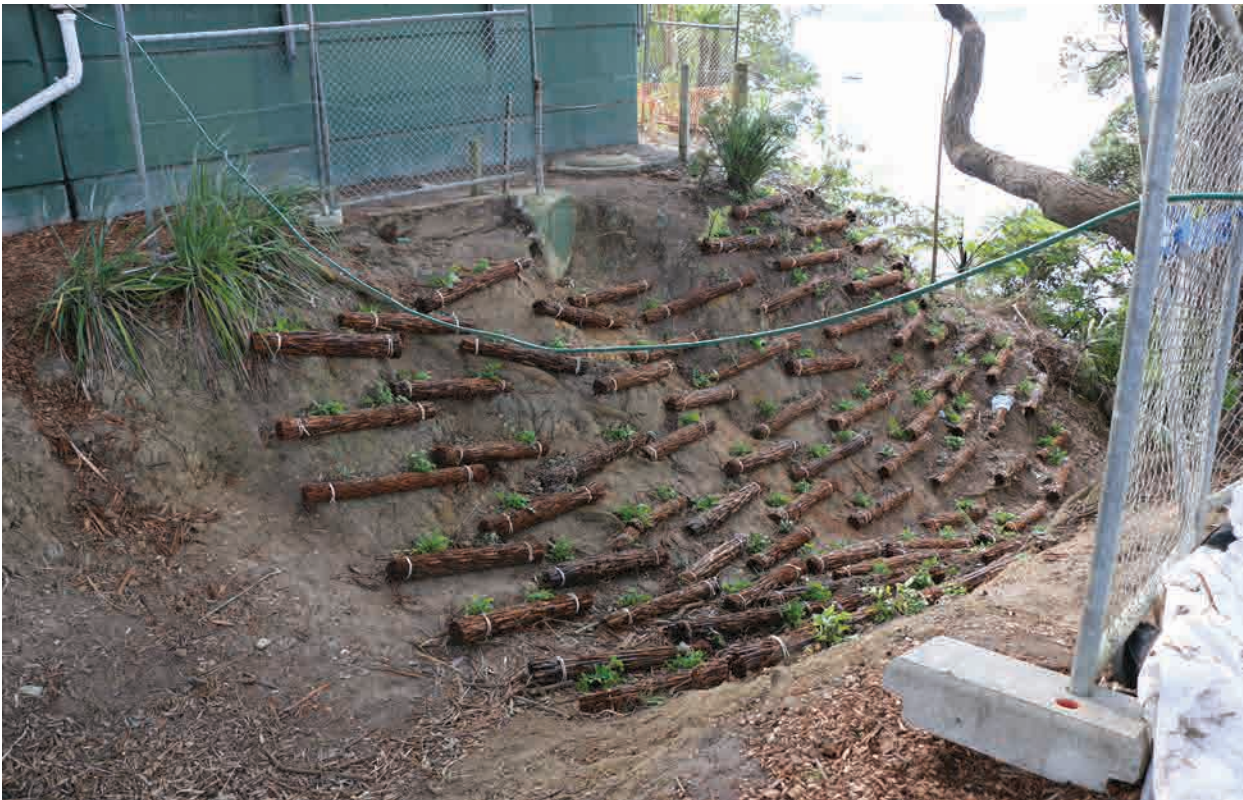
Figure 17. Ponga held in place in ditch prior to replacement foot bridge being installed.

The punga were installed within the eastern portion of the ditch to assist and encourage the stabilisation plants to grow. Due to the nature of the anchoring system, no archaeological material was encountered, and any impact on the ditch itself was minimal.

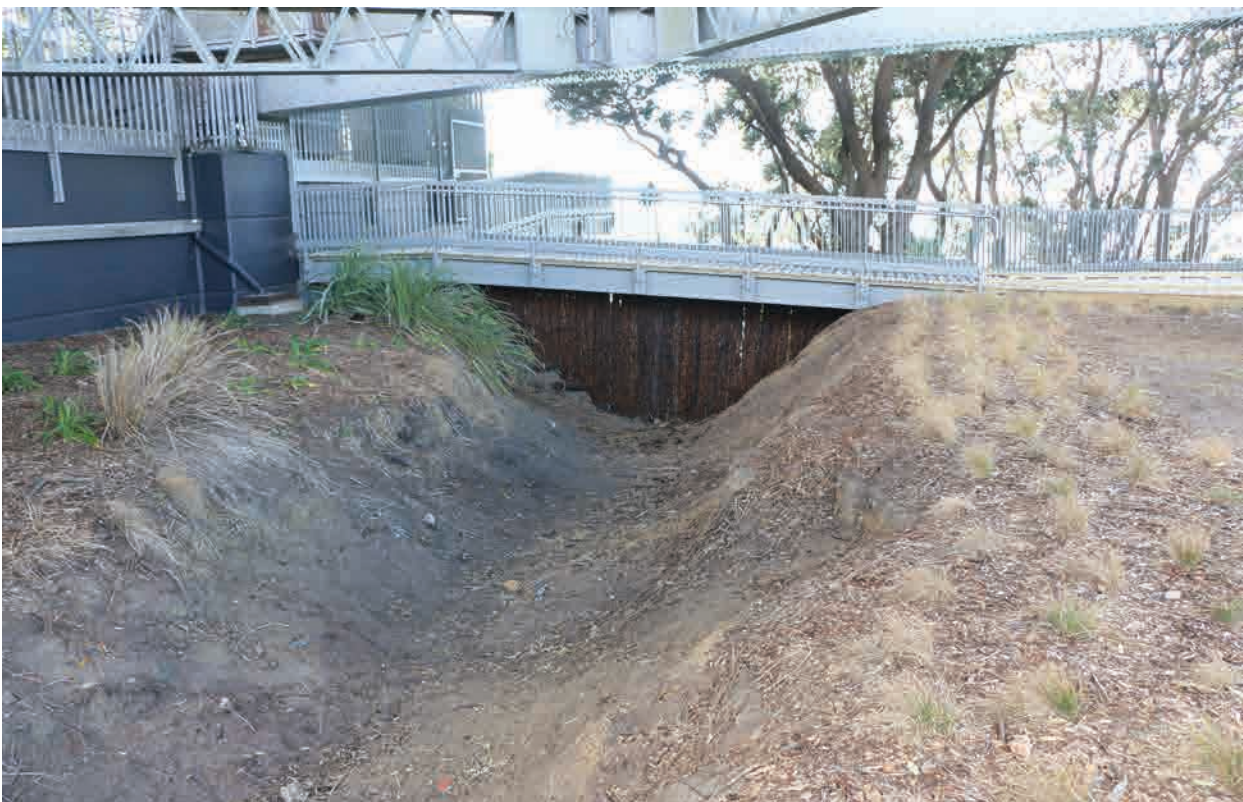
Figure 18. View of vertical ponga underneath foot bridge.

Ponga were also placed vertically beneath the foot bridge to prevent people from entering into the ponga stabilization area. This has also removed the last place where pedestrians could easily get to the cliffs on the eastern side of the pa both improving safety and allowing the stabilisation planting to grow unaffected by human interference.
